# A new experience for the Maroochy Regional Bushland Botanic Gardens

Finally, **Newsletter # 4**...our project activities in the Covid years 2020 - 2021...we are now well into the new 2021 year!..... And much has happened since our last newsletter...as promised last time the shaped, sanded and drilled planks (all 32 of them, and remember they ranged in lengths from 3 metres to 4 metres) were taken back to the timber yard for preservative treatment and duly returned to our shed.

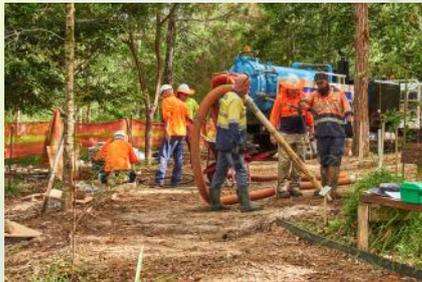
The pier holes were excavated by a vacuum/suction method in order to minimise damage to principal tree roots...a high pressure water jet displaces the soil and a giant vacuum cleaner sucks it up...the process whilst very impressive took a lot longer than we anticipated...

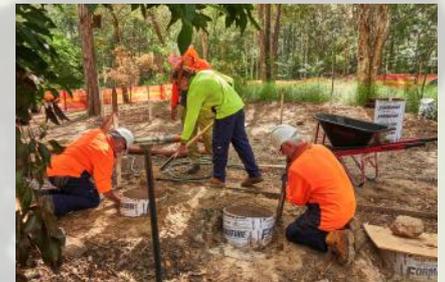
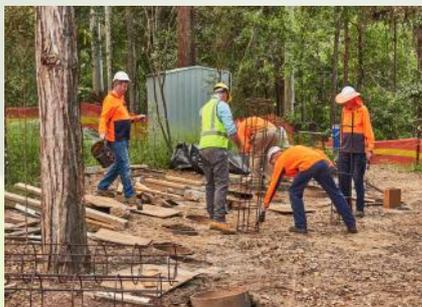
Reinforcement cages being placed in the holes

Once the holes were excavated cardboard caissons were installed to line the holes...and plywood safety covers were installed over each hole...this was also insurance against the holes filling up with water, in the event there should be rain...this didn't necessarily work all that well... and of course there was rain...lots of it...and the holes filled up...requiring ingenious methods of emptying them out...but we prevailed...

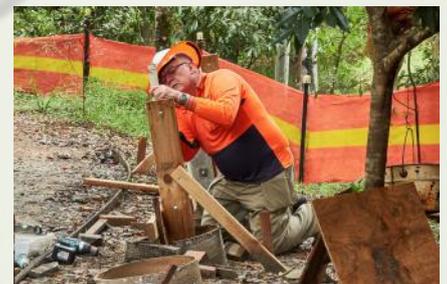
Ingenious systems employed to secure the steel spigots

The next three weeks were taken up by the installation of the first 7 steel spigots and the reinforcement steel cages and there was more rain...9 more spigots and it continues to rain, rain...in the last week or so (and 5 more spigots) the site has had 500mm of rain!!!

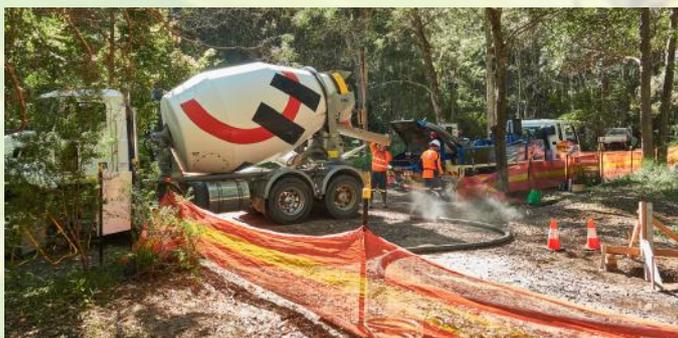
Concrete being poured

Onwards and upwards as they say and after numerous pump-outs of rainwater out of the holes we got to see the arrival of the concrete truck and pump. All footings were poured and another stage of the works was successfully completed.

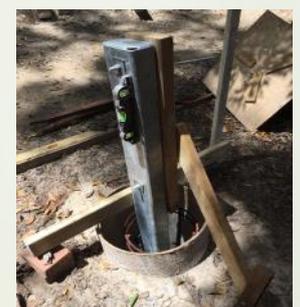
A typical spigot set up and ready for the concrete placement

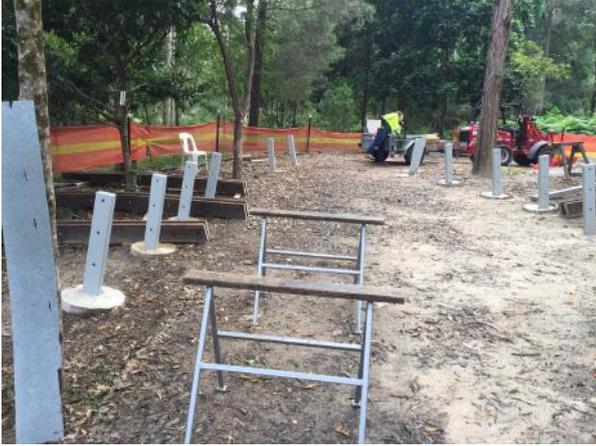
*Stirrups all in place, concrete poured and waiting for the timber posts to be installed*

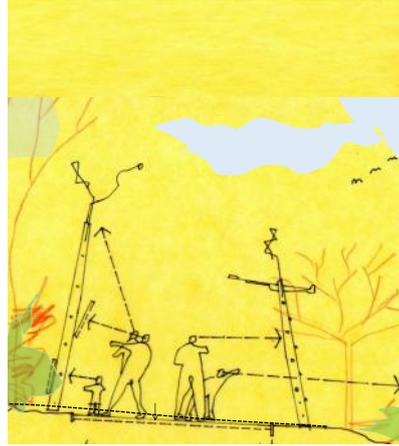
*A cross section through Node A as it was envisaged in the early days!!!*

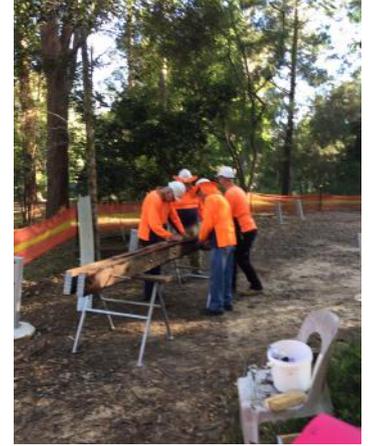
*The team in the process of assembling the posts into pairs...*

The next stage was for the assembly of the posts...ie the bolting together of the two sections of timber to form a single post element, each part separated from the other by a series of 75mm long x 50mmdia stainless steel tubes. Handling these huge lumps of timber was no mean feat...remember the tallest, 4m in length weighs approximately 110kg! However once again...onwards and upwards.

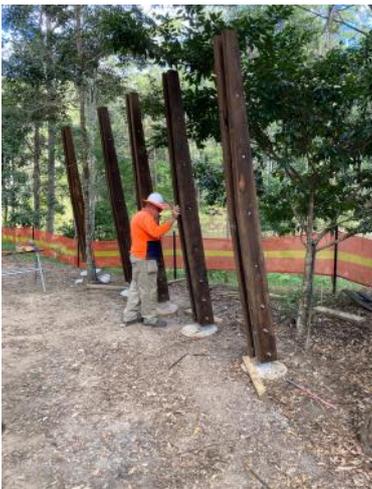
*Our supervisor making sure the posts are firmly in place and not about to fall over...*

So now, after assembly we were ready to install and after a few trial attempts it can be reported that there are now 16 posts standing proudly to attention along either side of the Node A site.

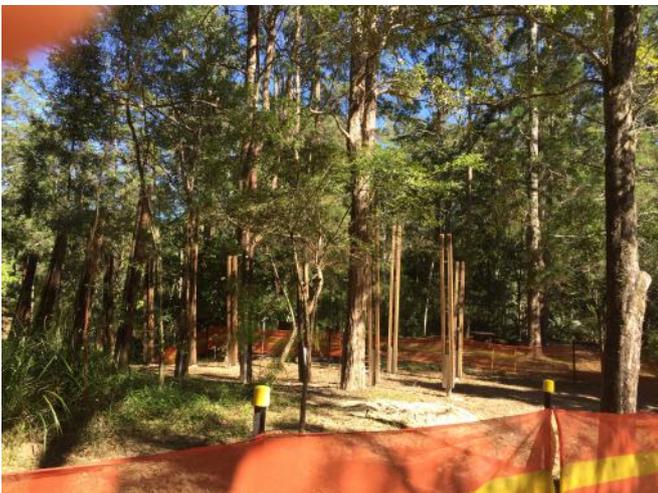
*The posts for Node A now in place...*

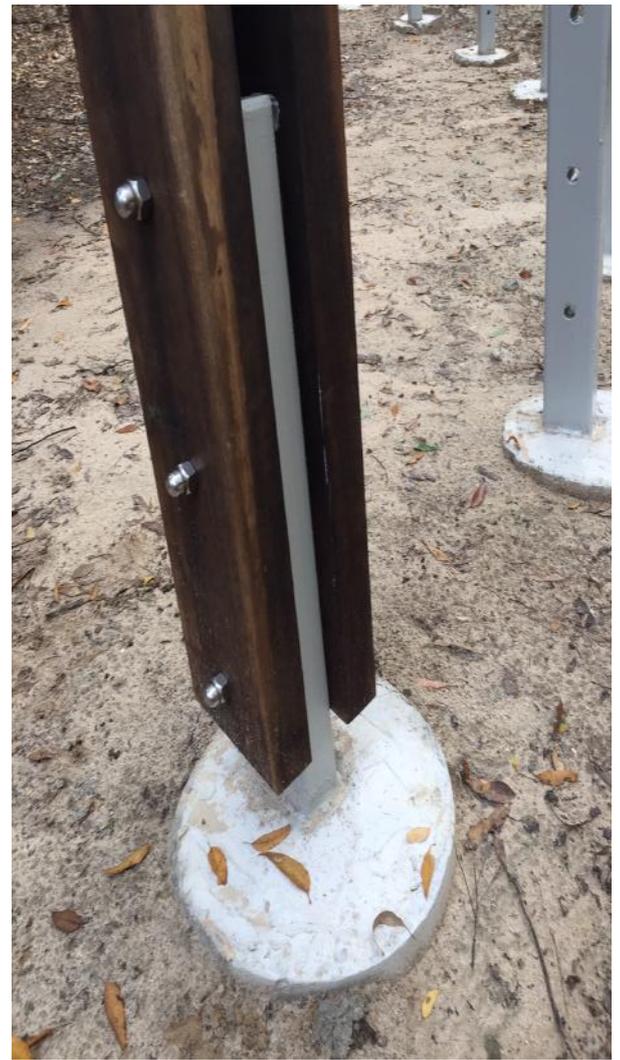
*A detail of the spigot/post assembly. Note the careful detailing of the steel work, the bolt locations and the concrete base. Eventually when the surrounding pathwork and landscaping has been completed the concrete base will no longer be seen.*
